# A Record of All Marker Bands Found in the Upper Rivet Rows of 2 Adjacent Bays From a Fuselage Lap Splice Joint

Scott A. Willard  
*Lockheed Martin Engineering and Sciences Company, Hampton, Virginia*

November 1995

National Aeronautics and  
Space Administration  
Langley Research Center  
Hampton, Virginia 23681-0001

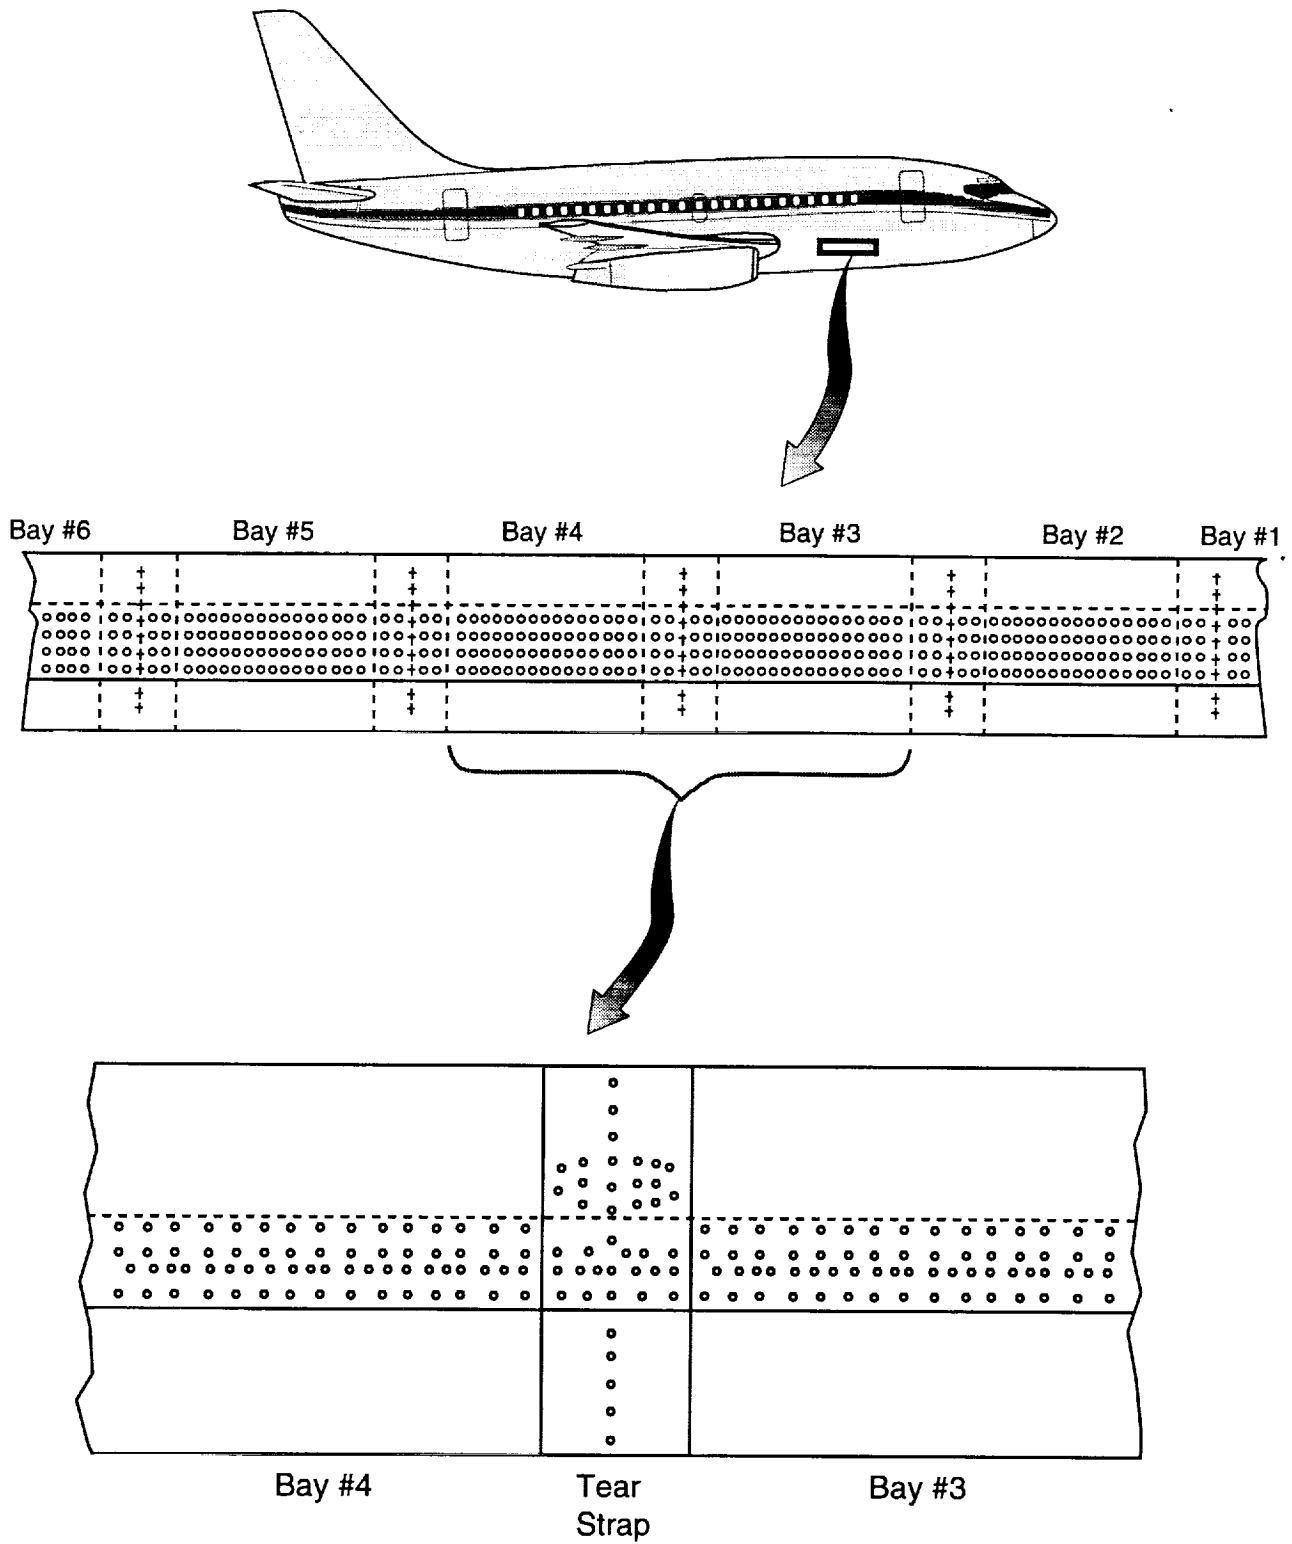
Thirty rivet holes comprising the upper rivet rows from two adjacent bays (bays #3 and #4) from a fuselage lap splice joint were examined for the purpose of this study (*Fig. 1*). Optical and scanning electron microscopy (SEM) were used to locate the marker bands.

Fig. 1 Bay #3 and Bay #4 from the widespread fatigue panel.

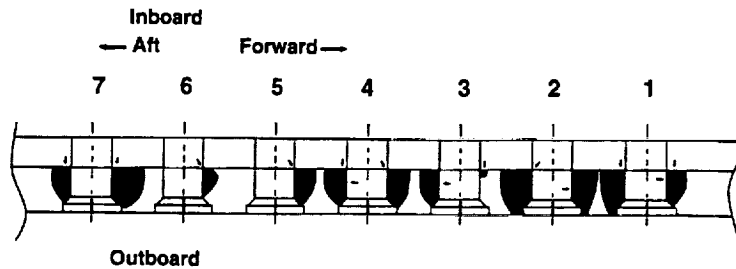
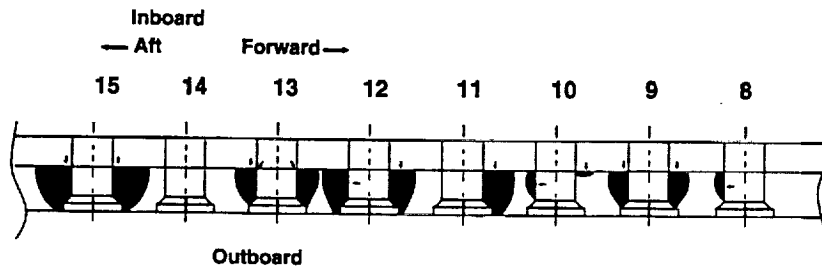
Fig. 2. Schematic of Bay #3 upper rivet row.

The upper rivet row of Bay #3 contained 29 cracks in 15 rivet holes ranging in size from 0.307 mm (0.012 in) to 4.890 mm (0.192 in). A summary schematic detailing the destructive examination results including crack location, crack length, crack morphology (not to scale), crack type, and initiation site are presented in *Figure 2*. No crack linkup occurred in this bay.

Hole #	Location	Length mm (in)	Type	Initiation site
1 (Aft)	Outer Skin	4.733 (0.186)	Fretting	Inner skin / outer skin
1 (Fwd)	Outer Skin	2.550 (0.100)	Fretting	Inner skin / outer skin
2 (Aft)	Outer Skin	2.300 (0.091)	Through	Inboard corner
2 (Fwd)	Outer Skin	4.222 (0.166)	Through	Not determined
3 (Aft)	Outer Skin	1.625 (0.064)	Countersink	Counterbore
3 (Fwd)	Outer Skin	1.071 (0.042)	Fretting	Inner skin / outer skin
4 (Aft)	Outer Skin	1.833 (0.072)	Countersink	Multiple
4 (Fwd)	Outer Skin	2.439 (0.096)	Countersink	Inboard corner
5 (Fwd)	Outer Skin	1.737 (0.068)	Countersink	Inboard corner
6 (Fwd)	Outer Skin	0.662 (0.026)	Countersink	Inboard corner
7 (Aft)	Outer Skin	1.419 (0.056)	Countersink	Inboard corner
7 (Fwd)	Outer Skin	2.500 (0.098)	Fretting	Inner skin / outer skin

Hole #	Location	Length mm (in)	Type	Initiation site
8 (Aft)	Outer Skin	0.742 (0.029)	Countersink	Center of counterbore
9 (Aft)	Outer Skin	1.737 (0.068)	Countersink	Inner skin / outer skin
9 (Fwd)	Outer Skin	1.130 (0.044)	Countersink	Inner skin / outer skin
10 (Aft)	Outer Skin	0.905 (0.036)	Countersink	Center of counterbore
10 (Fwd)	Outer Skin	0.307 (0.012)	Fretting	Inner skin / outer skin
11 (Aft)	Outer Skin	4.160 (0.164)	Countersink	Inner skin / outer skin
12 (Aft)	Outer Skin	3.220 (0.127)	Through	Center of counterbore
12 (Fwd)	Outer Skin	4.890 (0.192)	Through	Inner skin / outer skin
13 (Aft)	Outer Skin	2.030 (0.080)	Countersink	Multiple
13 (Fwd)	Outer Skin	2.500 (0.098)	Countersink	Inner skin / outer skin
15 (Aft)	Outer Skin	3.040 (0.120)	Through	Inner skin / outer skin
15 (Fwd)	Outer Skin	2.980 (0.115)	Through	Inner skin / outer skin

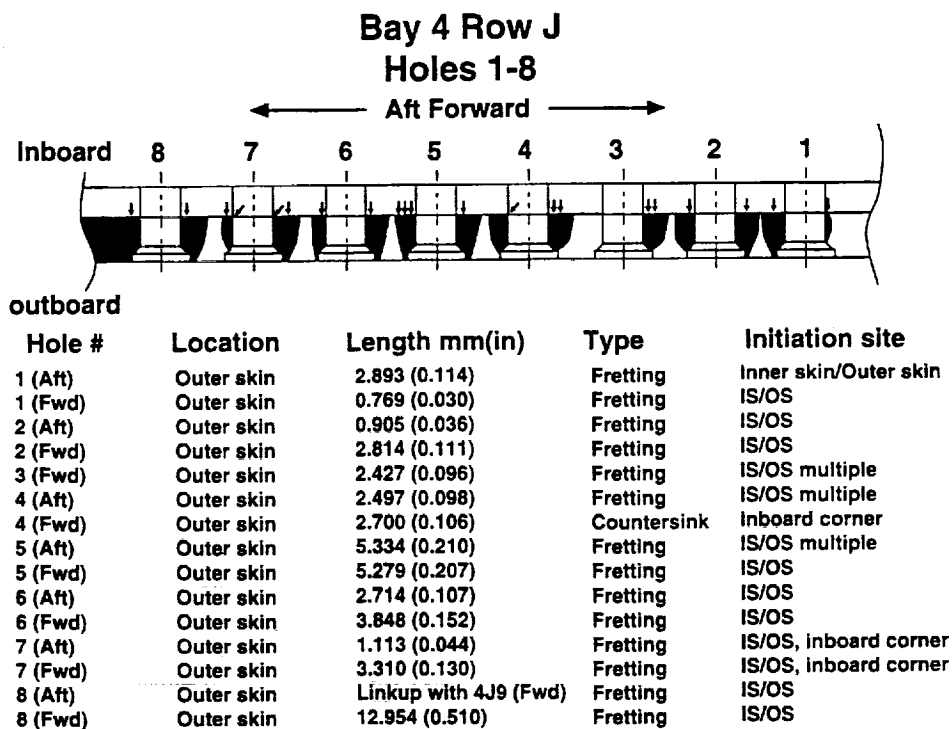
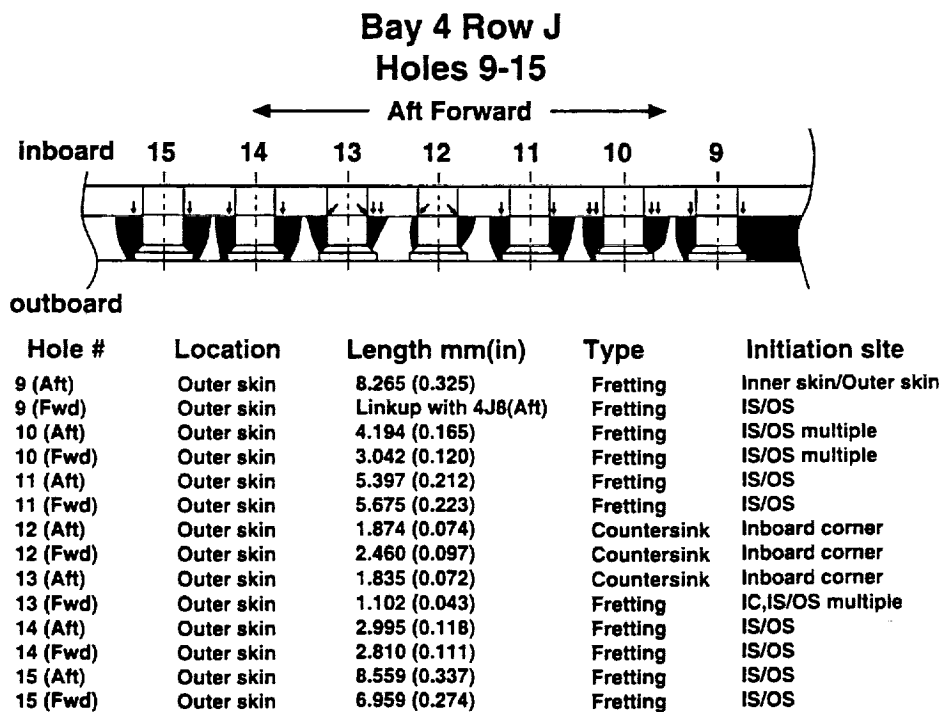
*Fig. 3. Schematic of Bay #4 upper rivet row.*

The upper rivet row of Bay #4 contained 24 cracks in 15 rivet holes ranging in size from 0.769 mm (0.030 in) to 12.954 mm (0.510 in). A summary schematic detailing the destructive examination results including crack location, crack length, Crack morphology (not to scale), crack type, and initiation site are presented in *Figure 3*. Crack linkup occurred between rivet holes 8 and 9.

Although nine 50K cycle sets were found in bay #4, 10 sets of 50K marker bands went undetected where they logically should have existed. Due to increasingly high growth rates at the longer crack lengths, the marker bands became very large in 6 of these 10 cases. The light reflected from the marker bands was too diffuse for them to be adequately defined. This phenomenon was most prevalent in the cracks that linked up in the center of the bay where this phenomenon occurred on 3 cracks emanating from 2 rivet holes.

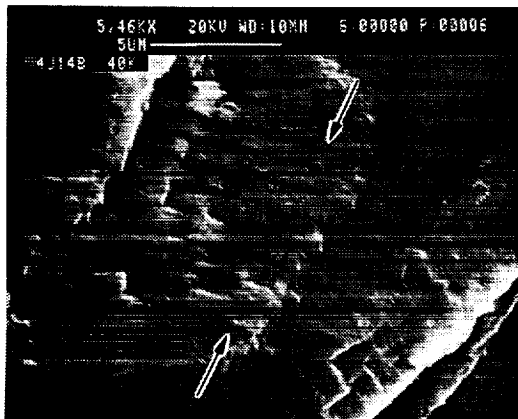
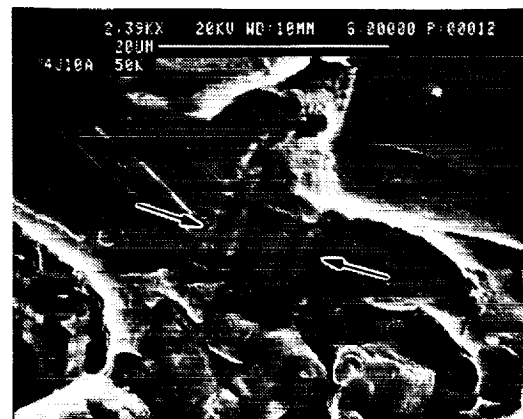
Unique marker blocks were used to create distinct marker bands at regular intervals of 10,000 cycles (*Fig. 4*). A marker block consists of a

**Fig. 4.** SEM micrographs of: a) 6 marker bands between arrows comprising a 30 K set of marker bands. b) 10 marker bands between arrows comprising a 40 K set of marker bands. c) 4 marker bands between arrows comprising a 40 K set of marker bands.
